PRODUCT SUPPORT BULLETIN **No.0194**

SUBJECT: Modification to MCP800 Hydraulic Pulverizers

EQUIPMENT AFFECTED: MCP800 Hydraulic Pulverizers sold in 1996

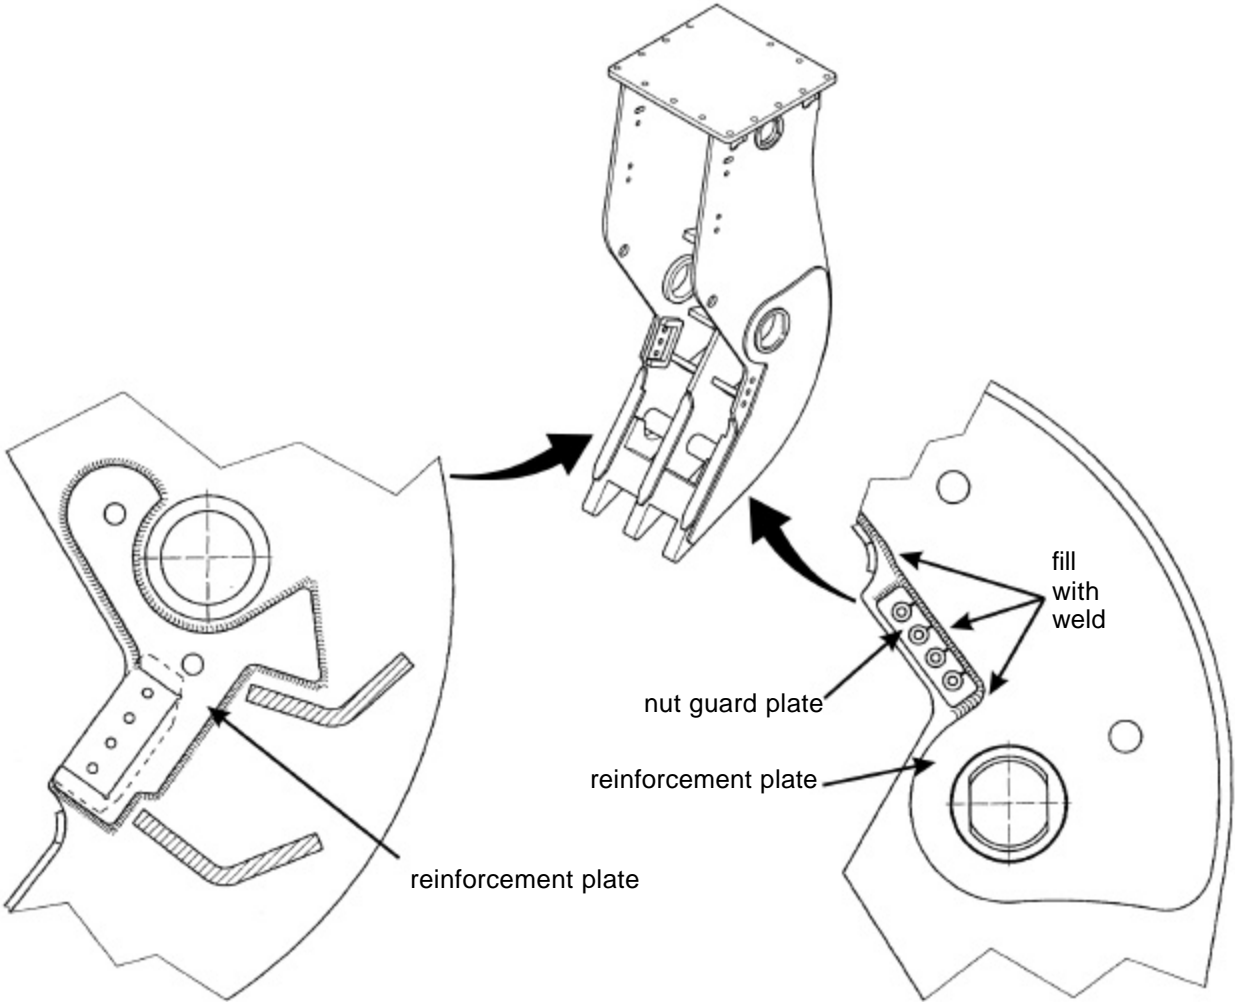
Figure 1

SITUATION: It has come to the attention of Teledyne that extra reinforcement is needed to prevent premature cracking of the frame in the cutter blade area of the MCP800 Hydraulic Pulverizer.

SOLUTION: (drawing attached) 1) With the blade in place, position the reinforcing plate as shown in Figure 1, and secure with clamps. 2) Remove the blade. 3) Weld the reinforcement plate around the perimeter as shown in Figure 1. 4) On the outer side of the frame, fill the gap between the nut guard plate and the outer reinforcement plate with weld, as shown in Figure 2. 5) Replace the blade to complete the procedure. 6) Repeat the procedure for the opposite side frame.
