**BREAKER  
TECHNOLOGY,  
INC.**

# SERVICE BULLETIN

No.208

SUBJECT: Preventing pin damage during boom installation.

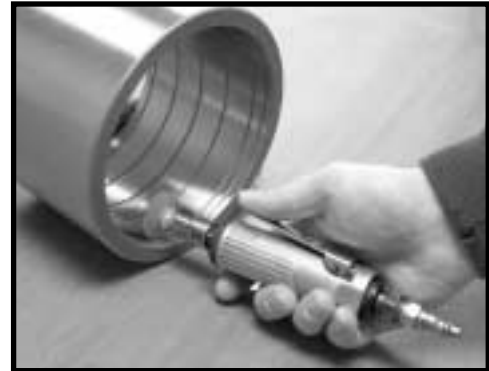
Figure 1

SITUATION: The bushing has a helical grease groove along the inner length that join a circular groove at the outer end of the bushing. The intersection of these two grooves form a sharp edge. This sharp edge may scratch the pin during assembly.

1. Wipe the bushing with solvent to remove surface grease.
2. Using a small grinder (Fig. 1), remove the material from between the two grooves (Fig. 2) for a distance of 100mm back from this intersection (50 mm for the smaller bushings).
3. Use a piece of emery cloth to lightly sand the area smooth after grinding.
4. Inspect the mating pins for any damage. Sand out any scratches on the pins using emery cloth.
